MAKE DATA MATTER.

SIXTH EDITION

2020 PV Module Reliability Scorecard

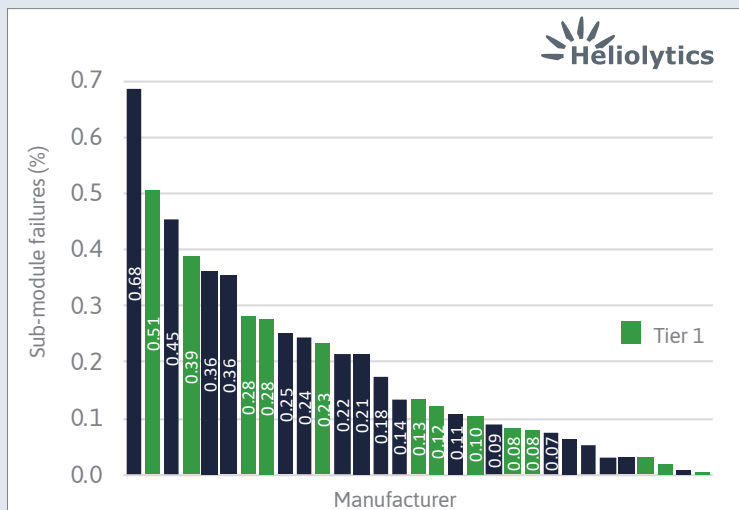
The bar graph shows the percentage of modules with sub-module faults from different manufacturers, ranging from 0.68% down to almost 0.00%.

The chart to the left shows sub-module failures per module manufacturer. These are failures with at least one third of the module in short circuit, leading to at least a 33% drop in module power. They are a good indicator of major reliability issues caused by poor soldering, diode failures, backsheets and/or cell reliability issues. The data set covers manufacturers that supplied five or more sites scanned by Heliolytics.

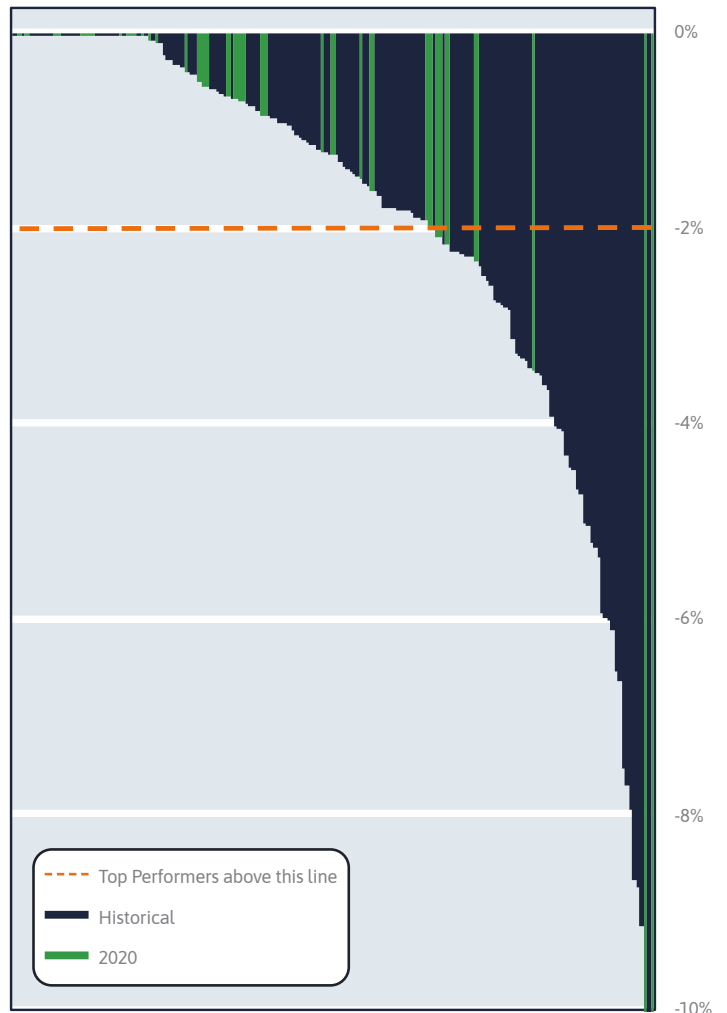
Power Degradation from TC Test Sequence for Each Module Model

Median power degradation for all 2020 Scorecard eligible module types was 0.67%. However, some modules did not perform to this level, including the example shown here where poor cell metallization and imperfect soldering of the cell interconnection ribbons led to a 4% power degradation. Other TC failures include two module types that experienced diode failure leading to catastrophic power loss and one module type that suffered a wet leakage failure due to a breakdown in the module's electrical insulation. While TC performance has improved overall, PVEL observed major failures in some BOMs.

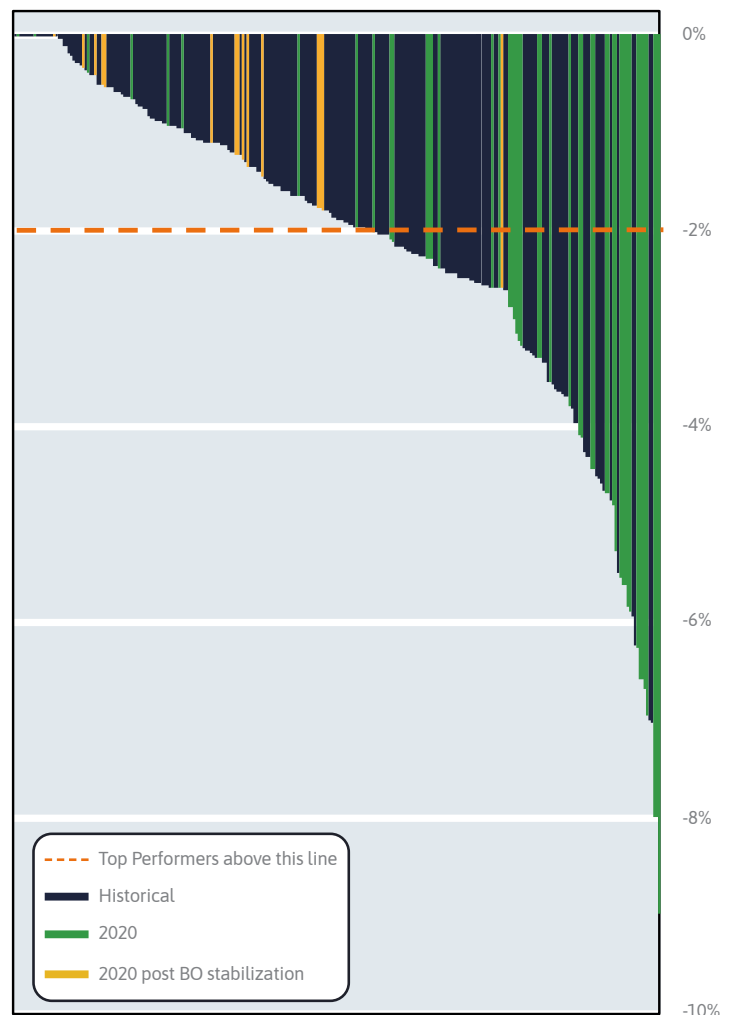
Power Degradation from DH Test Sequence for Each Module Model

Damp heat is a critical test to identify underperforming modules susceptible to moisture ingress and corrosion. This can be seen in the example EL images, where the module performed well to the 1000-hour IEC 61215 duration. The performance difference after 2000 hours is stark: corrosion is seen along the bus bars and edges of the cells, and power degradation surpasses 9%.

The graph above shows power degradation results for both pre- and post- BO stabilization. In the most extreme example, PVEL measured 8.4% degradation in a post-DH2000 module that recovered to 1.3% degradation following BO stabilization. While some industry research has shown that BO destabilization is a test artifact that occurs during periods of high heat and no current (conditions which do not occur in the field¹), more research is required to determine if destabilization will occur in the 25+ year lifetime of a module. It is worth noting this phenomenon only affects some PERC modules.

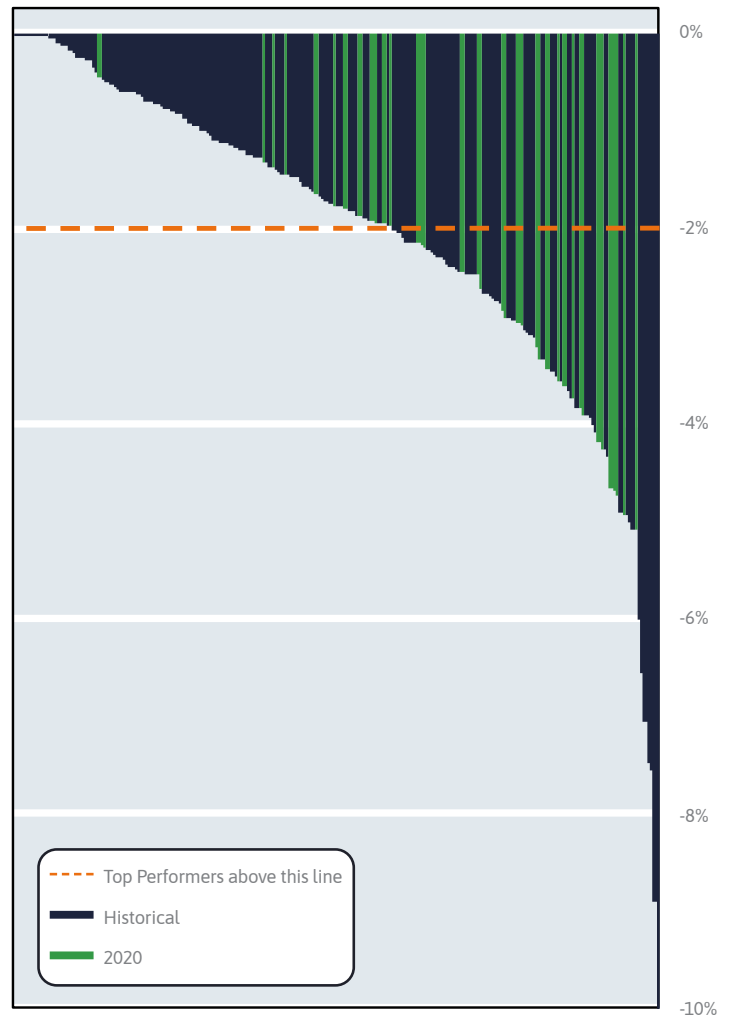
Power Degradation from DML Test Sequence for Each Module Model

Note: approximately 80% of the historical data includes only 10 humidity freeze cycles, which reflects past PQP test durations.

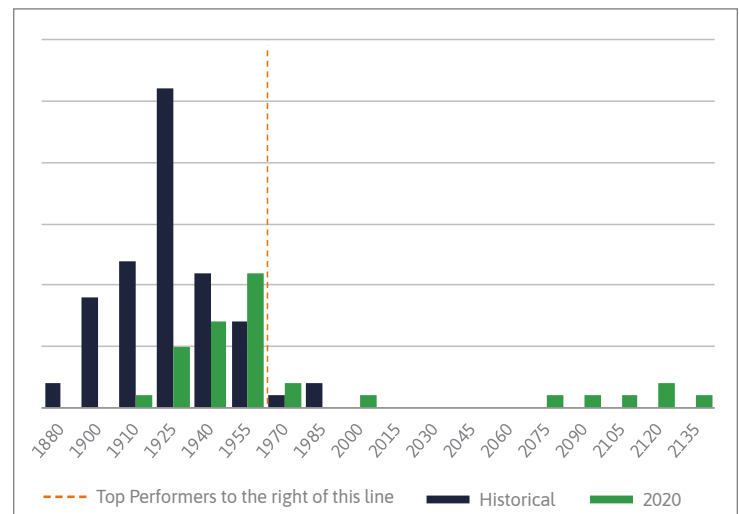
kWh/kWp for 1 MW project in Las Vegas,

The presented historical data provides context for the performance improvements seen in the 2020 Scorecard PAN dataset. Module energy yield is clearly increasing with improved module designs. Of PVEL's historical data from all PQPs since 2016, only 4% of modules tested would receive a 2020 Scorecard Top Performer designation.

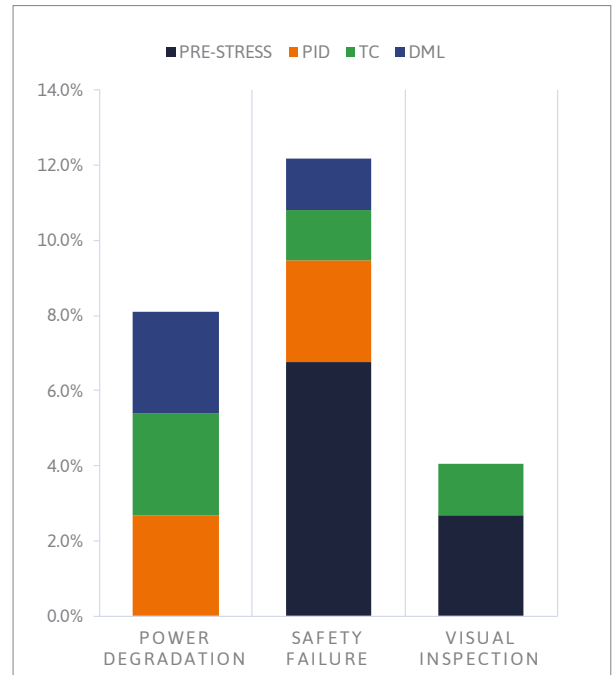
The chart below describes failures per test per BOM that occurred in PQP testing for the 2020 Scorecard. Pre-stress failures are those that were detected upon initial inspection prior to testing.

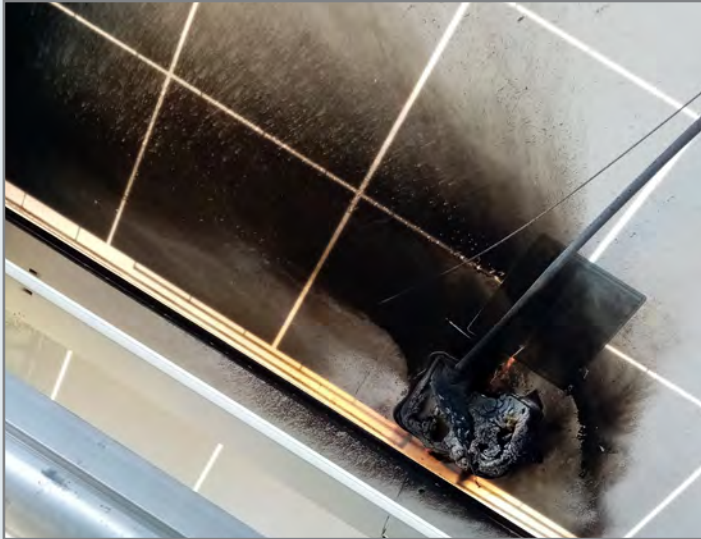
The image above shows a PV module at the project site with a junction box that melted due to electrical arcing.

A 50 MW PV plant in Africa built in 2013 began to exhibit serious failures from poor soldering and failed diodes after just five years of operation.

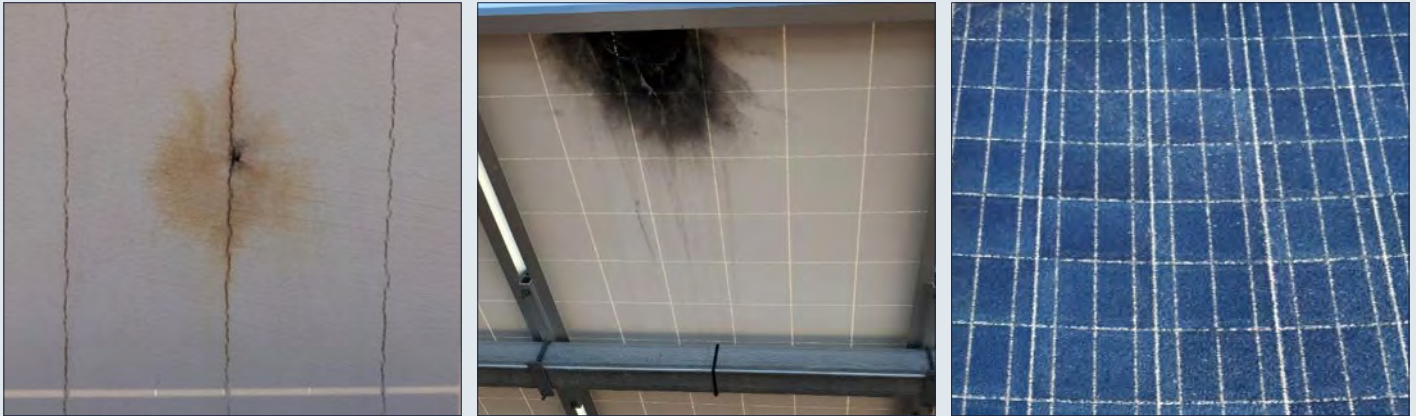
The pictures above are from a 17 MW project in the Southwest U.S. One hundred percent of the backsheets in this project are cracked. The severe scorching in the backsheet above was caused by electrical arcing at the backsheet cracks that intercept the frame. The thermal event shattered the front-side glass.

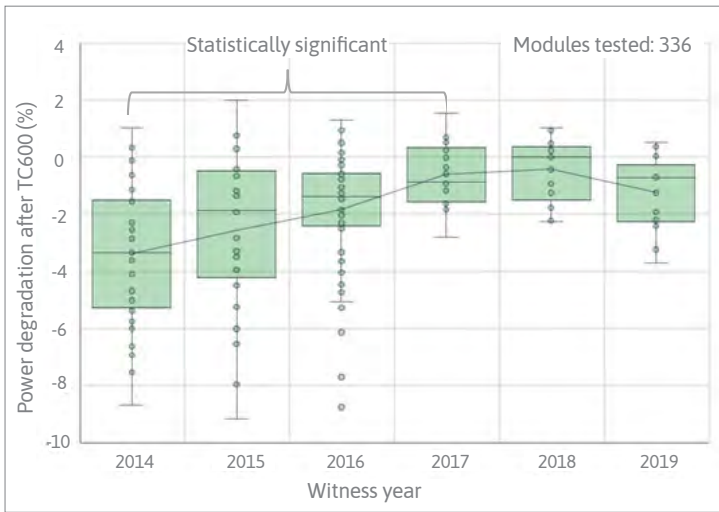
DNV GL analyzed PVEL PQP test results from 2014 to present. While the PQP has evolved over time, TC600 and DH2000 have remained common tests with statistically significant trends. TC600 results improved from 2014 to 2017 followed by a plateau with little degradation (see figure below left). This improvement may be explained by the transition to monocrystalline cells, more busbars, and thicker encapsulants. However, damp heat results indicate a deteriorating trend since 2015 (see figure below right). This may be due to the adoption of PERC cells which may require the additional boron-oxygen LID stabilization step following DH2000. Alternatively, it may reflect utilization of non-fluoropolymer backsheets or thinner screen-printed fingers, which may be more sensitive to corrosion via moisture ingress.

Results of the thermal cycle and damp heat tests since 2014

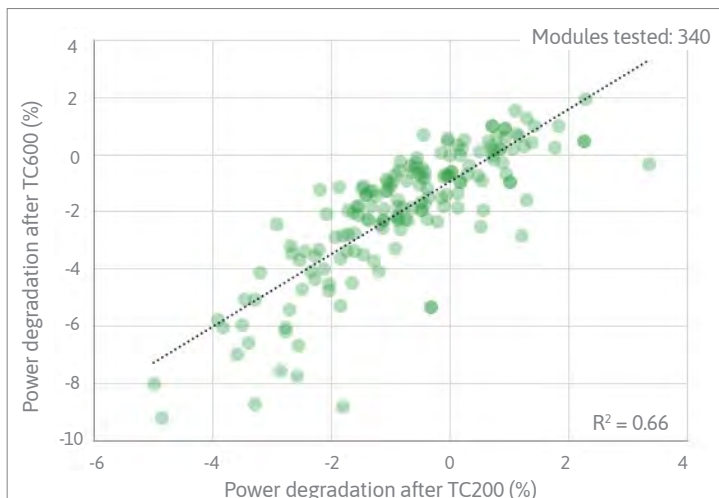
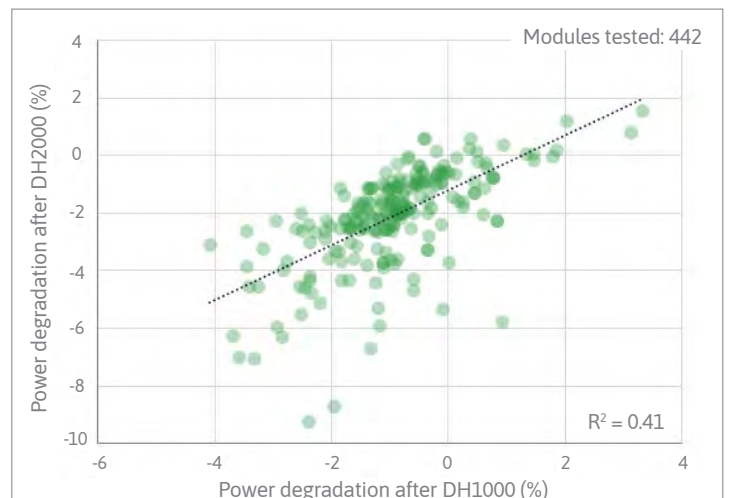
For the thermal cycling test, the correlation between 200 cycles and 600 cycles indicates no new mechanisms are being introduced by the 600 cycle test, yet stopping at 200 cycles might be premature (see figure below left). Reviewing the historical 600 cycle and 800 cycle correlation indicates that TC600 is a sufficient test duration. The damp heat correlation between 1000 hours and 2000 hours suggests 1000 hours is not an adequate substitute for 2000 hours (see figure below right), while the historical correlation between 2000 and 3000 hours indicates that less relevant failure mechanisms may be introduced. The data shows that 2000 hours is optimal.

Scatterplots showing correlations between various stages of the TC and DH tests

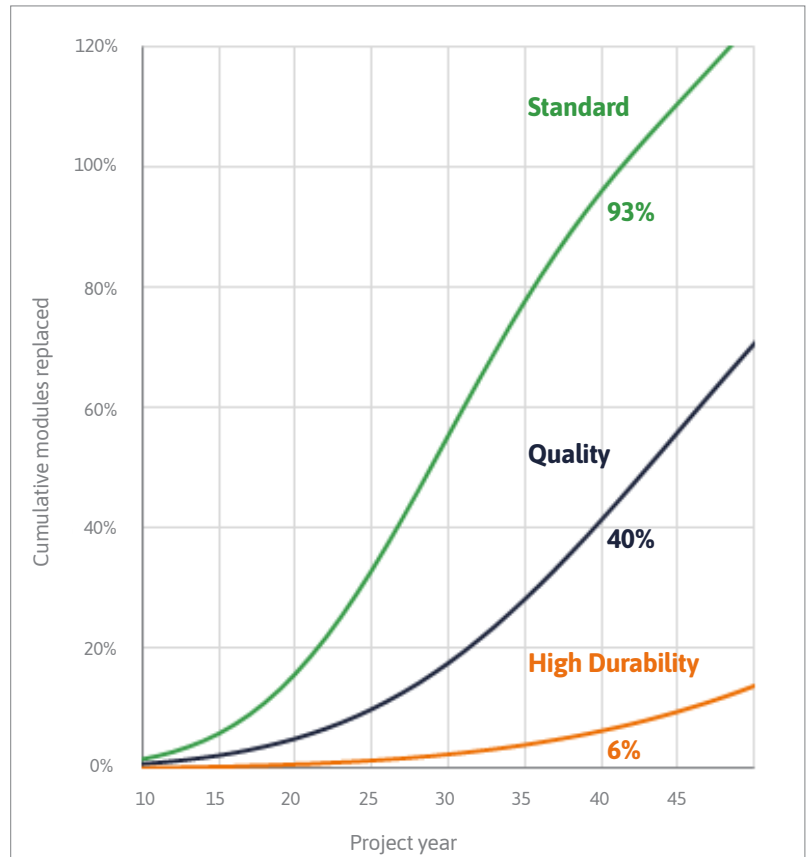
Cumulative modules replaced for the three module classifications: Standard, Quality and High Durability.
